Stauf SMP-960 Glue

In-Situ Impact Sound Insulation Test Report

Document No.
30U-12-0052-TRP-302053-0

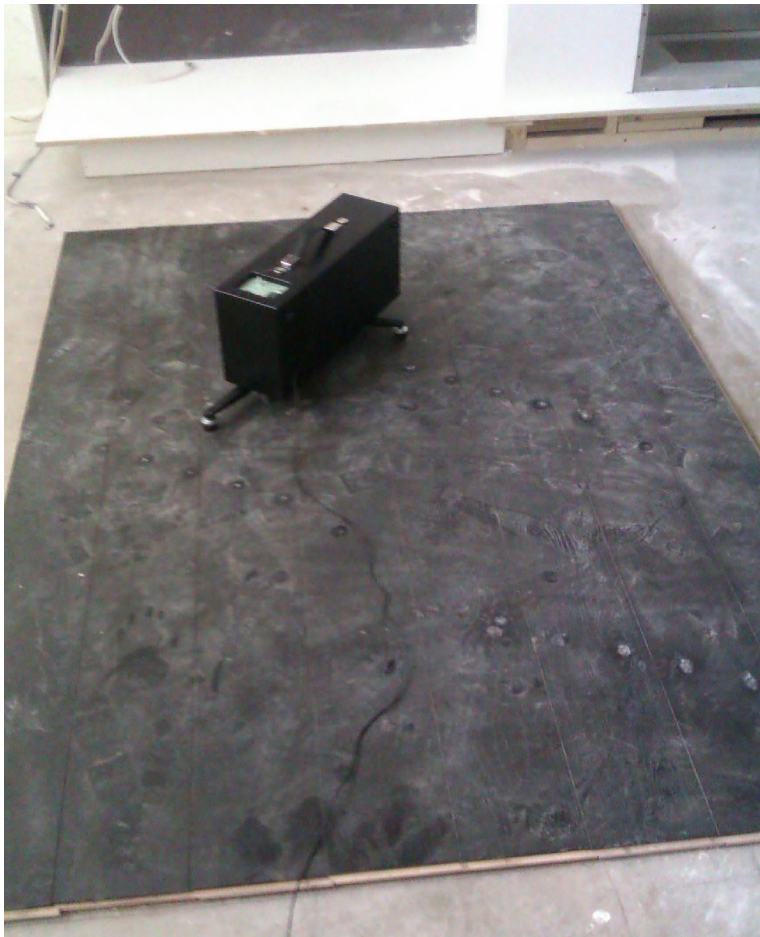
Measurements of the Impact Sound Insulation was conducted in accordance to the procedures of AS ISO 140.7. A standard tapping machine was placed at four different locations on the timber flooring area in the source room (unit 1902) at an angle of 45° with the floor board joints. (See **Figure 1**).

Figure 1: Tapping machine in-situ
